# Concrete Heritage: Challenges in Conservation

Ruben Paul Borg

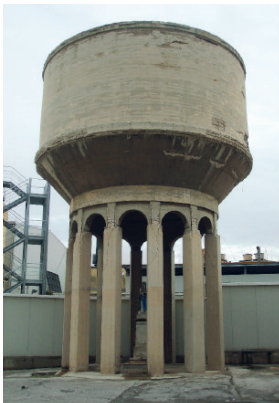
**Figure 1a. Reinforced Concrete Water Tower, Public Abattoir, Marsa, Malta.**

The Water Tower consists of a large reinforced concrete structure, c.14.5 m high with a tank having an internal diameter of c.9.5m. The tank consists of a shell structure with a cylindrical drum resting on a truncated conical structure with a dome at the base and with ring beams at the top and between each element. The tank rests on a ring beam supported on 12 slender reinforced concrete columns with a reinforced concrete foundation ring at the base. The structure has been repaired in the 1970s and the repair intervention included the strengthening of the 12 columns using a reinforced concrete jacket.

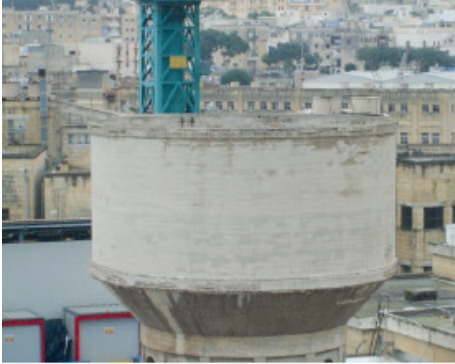
**Figure 1b.** The upper part of the structure consisting of a reinforced concrete tank.

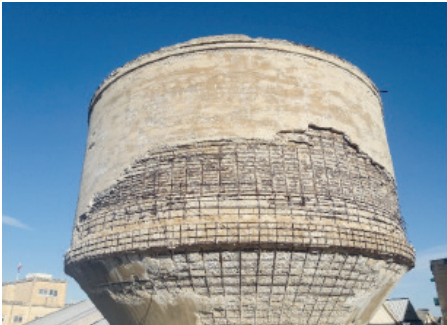
**Figure 2a.** Degradation on the south face of the tank, corrosion of reinforcement, spalling and delamination of concrete.

There is evidence that it used to be filled in with brackish and sea water. The age of the structure including the use of sea water in the tank, its location close to the sea in the industrial area of the Grand Harbour and other aspects have contributed to its degradation. This is primarily due to the corrosion of its reinforcement, extensive on the south facing side of the tank. Carbonation of concrete and chloride ion penetration through the concrete structure resulted in the corrosion of reinforcement, cracking, spalling and delamination with loss of concrete section and loss of reinforcement. The combined effects of corrosion-related processes, wet and dry cycles and stresses in the structure in operation, all contributed to degradation.

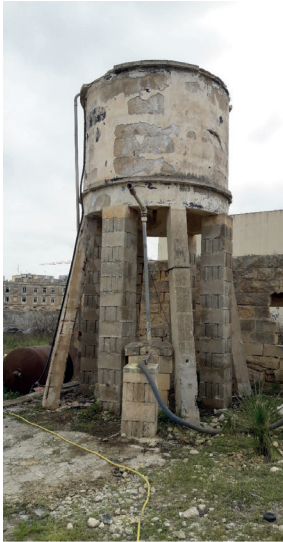
**Figure 3a. Water Tower at the Gzira Pumping Station, Malta.**

is c.6m high and the cylindrical drum tank is c.2m high with an external diameter of c.3m, resting on a ring beam supported by four, c.3.5m high inclined reinforced concrete columns. The main cause of degradation is concrete carbonation resulting in loss of passivation, corrosion of reinforcement and spalling and delamination of the concrete. As a result of the degradation of the four reinforced concrete columns, an additional four columns were constructed as temporary supports using concrete blockwork. The structure is one of the few examples of reinforced concrete water towers in Malta.

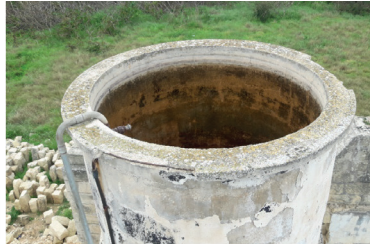
**Figure 3b. Water Tank.**

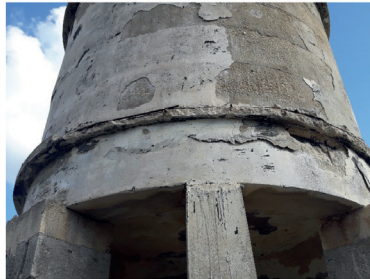
**Figure 3c. Degradation in the water tank and ring beam including cracking and spalling as a result of the corrosion of the reinforcement.**

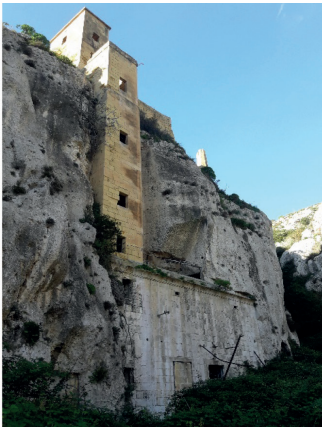
**Figure 4a. The Mġarr ix-Xini pumping Station.**

Two pipelines were constructed to supply water from the pumping station to a reservoir in Ta' Ċenċ and another one to Nadur. The pipeline transporting water to Nadur was supported by a bridge across the valley. This bridge still stands today within the valley basin in front of the pumping station, intended to support a cast iron pipe from the pumping station across to the other side of the valley into a tunnel and a trench up to the reservoir in the village of Nadur. The bridge consists of three arches supported on columns resting on the valley bed. A new pumping station was constructed in Xewkija in the 1960s and the galleries were deepened for water to be redirected to the Xewkija pumping station. The Mġarr ix-Xini station was abandoned and is in a state of disrepair (Galea, 2016). In general, the bridge is overgrown with vegetation and the pipework and its supports are damaged, but the structure itself does not show major signs of degradation.

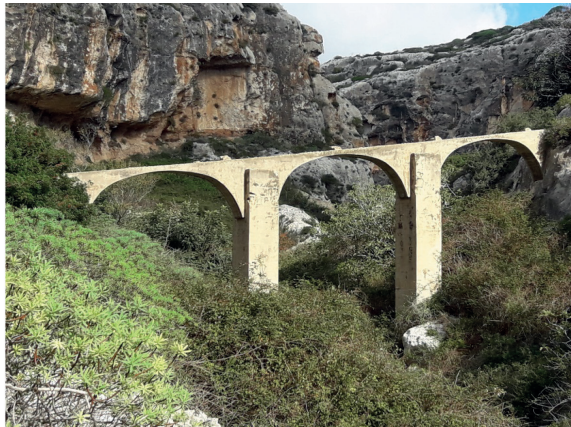
**Figure 4b. The three arched concrete bridge intended to support the water pipeline, crossing the valley.**

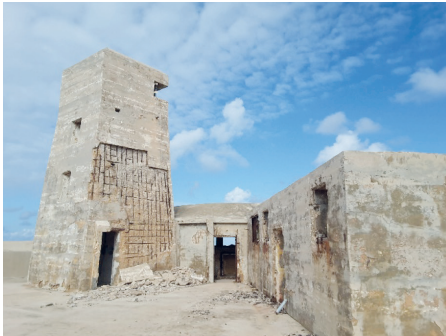
**Figure 5a. The Bastion No.4, twin 6-pdr QF gun emplacement with the characteristic high fire control tower at Fort Ricasoli.**

the gun emplacement and a reinforced concrete wall at the back to provide gun-crew with overhead protection. An underground magazine was located beneath the emplacement. The construction of the twin 6-pdr QF gun emplacements with their characteristic high fire control towers on the bastions were the final phase of the fortification of Fort Ricasoli in the 1930s, prior to World War II (Spiteri, 1996).

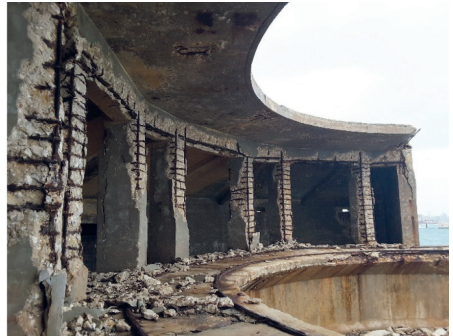
**Figure 5b. The passageway and overhead protection at the back of the twin 6-pdr QF gun emplacement at Fort Ricasoli, with severe degradation.**

The structures are immediately on the sea, exposed to air borne salts and to an aggressive XS marine environment. (EN206). The structure experiences extensive reinforcement corrosion, concrete spalling and delamination resulting in the extensive loss of sections. Since the structures include large concrete sections typical of a number of military heritage defence structures, they are still in a relatively stable condition though suffering severe degradation.

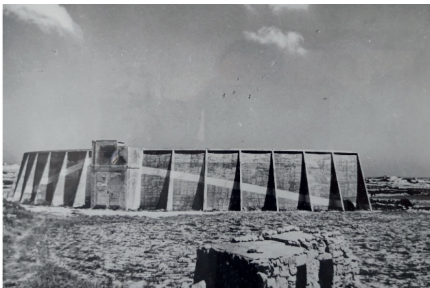
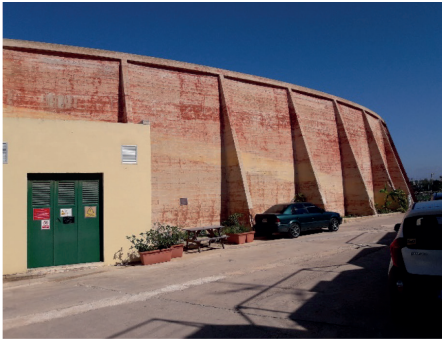
**Figure 6a. The Magħtab Acoustic Mirror buttressed structure from the back.**

Figure 7a. The Maghtab Acoustic Mirror buttressed structure from the back (2017).

The Acoustic Mirror in Magħtab is protected by the Planning Authority as a Grade 2 Scheduled property. The structure consists of the large parabolic concrete wall with buttresses at the back, small buttresses at its base on the front side and a large sloping platform in front leading to a trench.

The structure still retains its distinctive red, white and green paint pattern on the surface and is in general in a good state of repair. Though not located immediately on the sea, the structure is mainly exposed to airborne salts and moisture from the ground. A catalogue of defects was compiled for the structure and degradation mapping was undertaken for the entire structure. This exercise was followed by non-destructive assessment of the structure based on sounding, Schmidt hammer, ultrasonic pulse velocity, surface moisture and cover meter investigation. The main degradation was mapped for the entire structure. Spalling of the concrete was mapped in specific areas on the front wall, together with spalling and delamination in the lower parts of the reinforced concrete buttresses at the back. The degradation is associated with concrete carbonation resulting in loss of passivation and corrosion of reinforcement, higher moisture content in the lower sections, in particular along the buttresses on the south face.

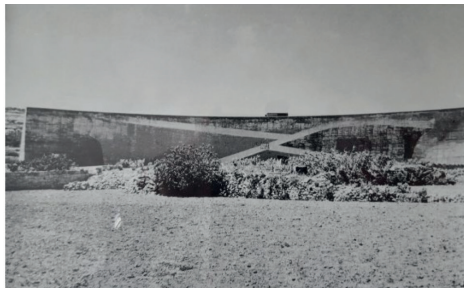
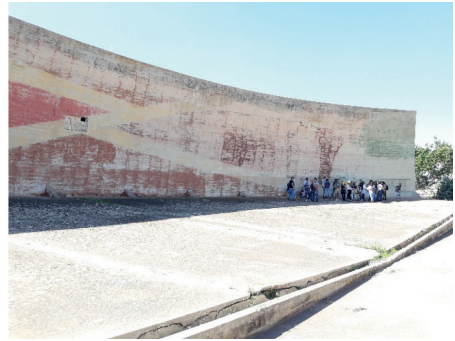
**Figure 6b. The Magħtab Acoustic Mirror structure front view.**

Figure 7b. The Maghtab Acoustic Mirror structure front view (2017).

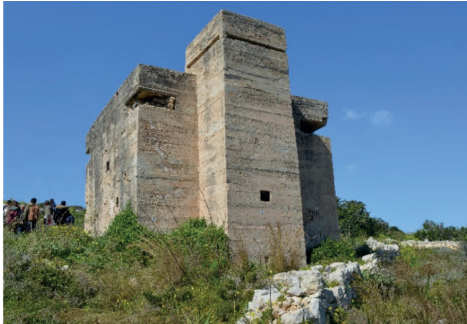
Figure 8a. Wied Dalam PillBox.

Pillboxes mainly consisted of reinforced concrete. Their design varied but nearly all had a rectangular observation cupola with all round vision slits or with a distinct turret on the side (Wied Dalam Pillbox). The supply of cement was limited so minimum sufficient thickness of walls and roofs were imposed for the maximum amount of pillboxes possible. Typically, the concrete is 15 inches thick. Curved corners were desirable because of ballistic standards but were rarely constructed due to the pressing conditions. The concrete was reinforced with 3/8" reinforcement at approximately 3" spacing horizontally and vertically.

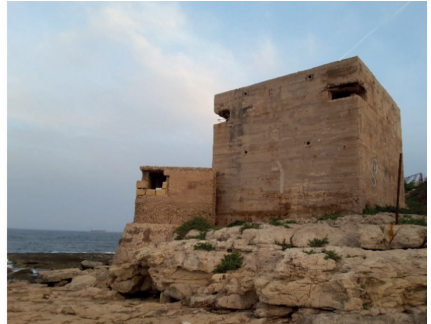
Figure 8b. Xghajra PillBox.

All pillboxes show significant signs of degradation though inland structures are in a better state than structures on the coast. Beach posts exposed to an aggressive marine environment show severe degradation, corrosion of reinforcement, spalling and delamination, and frequently loss of section. Some of the structures are observed to include sea-shells and pebble aggregate probably sourced from the nearby beach contaminated with sea water and a low quantity of cement, probably due to the pressing needs of construction over short timeframes with limited resources available. Some of the structures built in the later years during the war were also built under pressing conditions and manifest even greater degradation than structures built earlier in the 1930s. The state of the structures and the inherent defects in the materials and structure, present significant challenges for the conservation of these structures today.

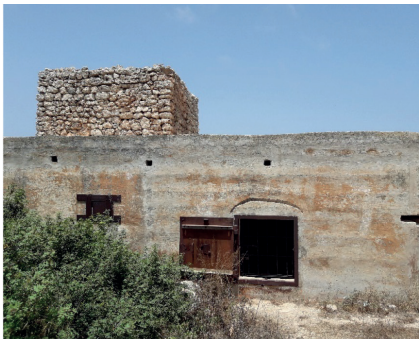
Figure 9a. Mistra PillBox.

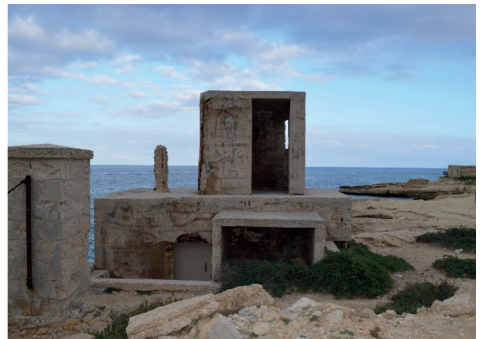
Figure 9b. Rinella Reinforced concrete post.

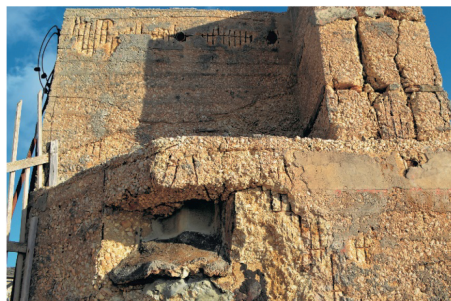
Figure 10. Prajjet, Mellieha Beach Post, degradation of concrete, plans and elevations of the structure.
